FATIGUE BEHAVIOR
OF GRAPHITE COMPOSITES

Final Report
(9 Feb. 1971 to 8 Feb. 1972)
February, 1972

Prepared Under Contract No. N00019-71-C-0212

IIT RESEARCH INSTITUTE

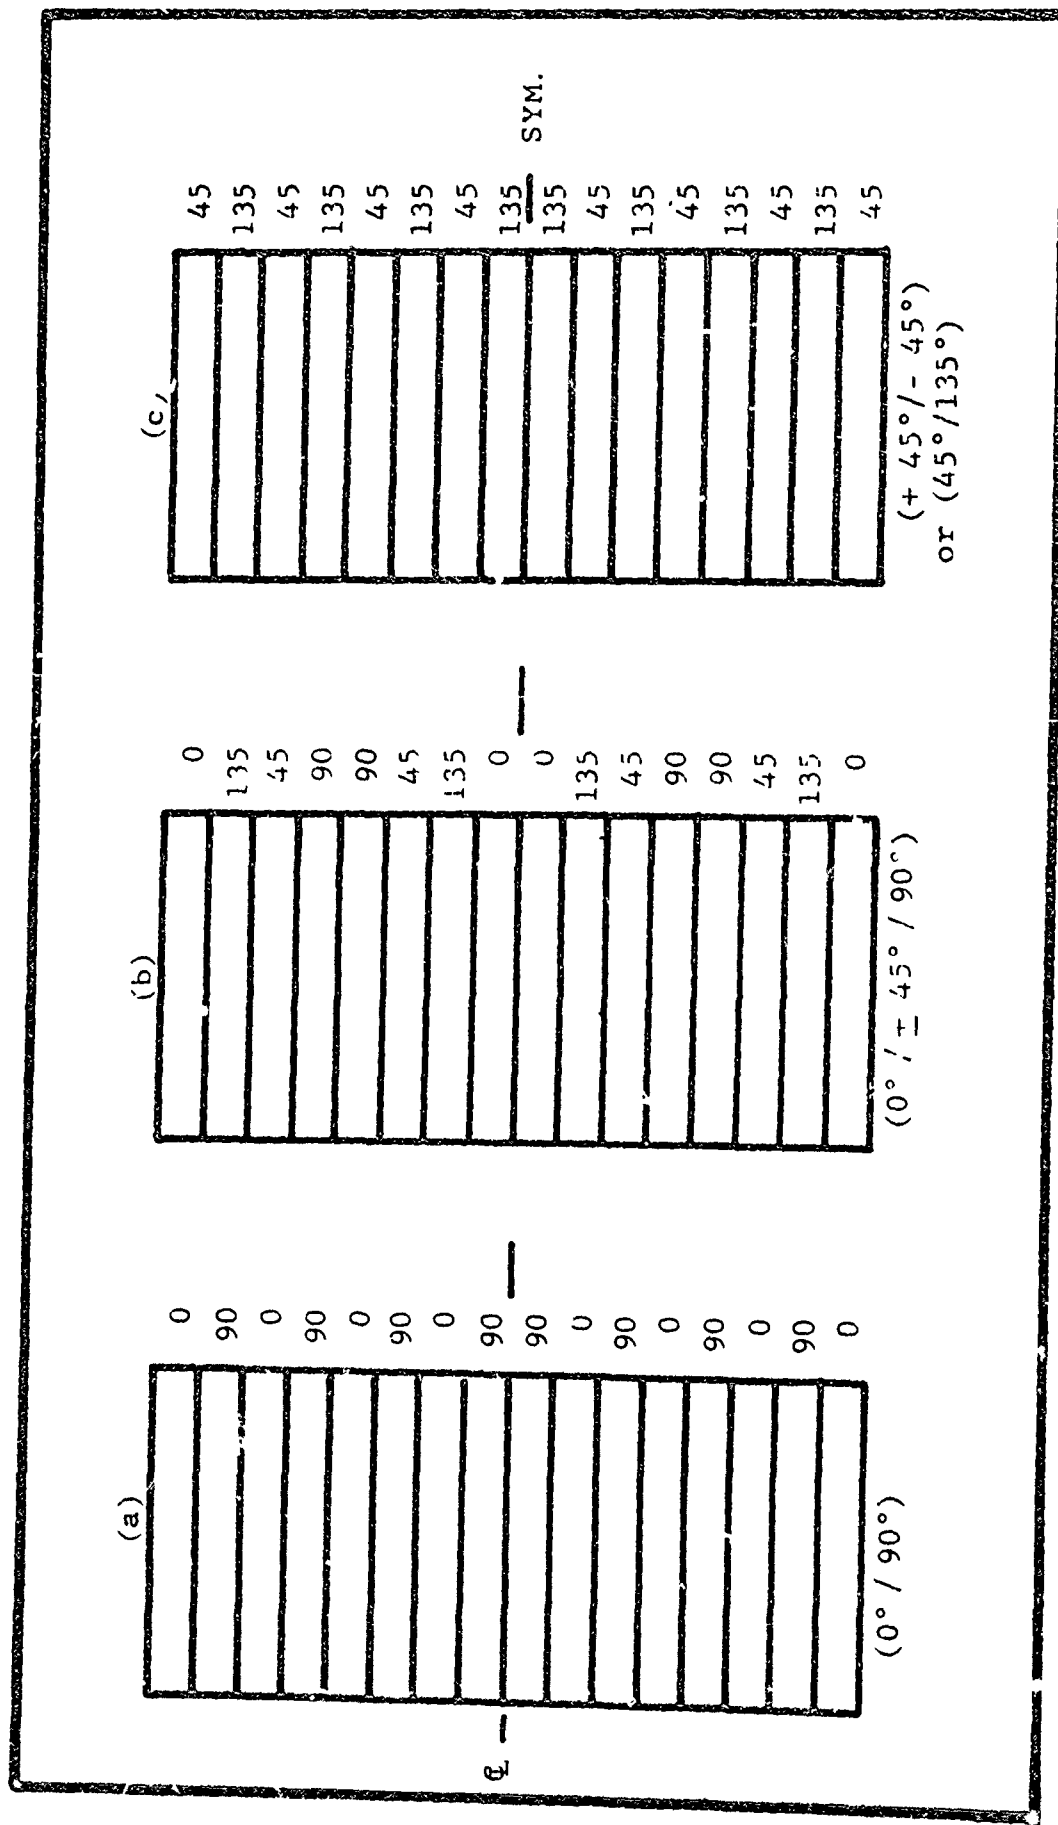
FIG. 1. ORIENTATION DETAILS OF MODMOR II/NARMCO 5206
PREPREG LAY-UP.

mens required in each category. Where the scrim cloth (104-20 x 20 glass cloth) was employed, it was interleaved between consecutive layers of the graphite prepreg material. The green lay-up was subsequently covered with two bleed cloth layers and finally with a teflon coated glass cloth. Before placing the lay-up in the autoclave, a barrier dam was placed surrounding the whole package to provide the vacuum environment. The cure cycle followed was according to the following schedule:

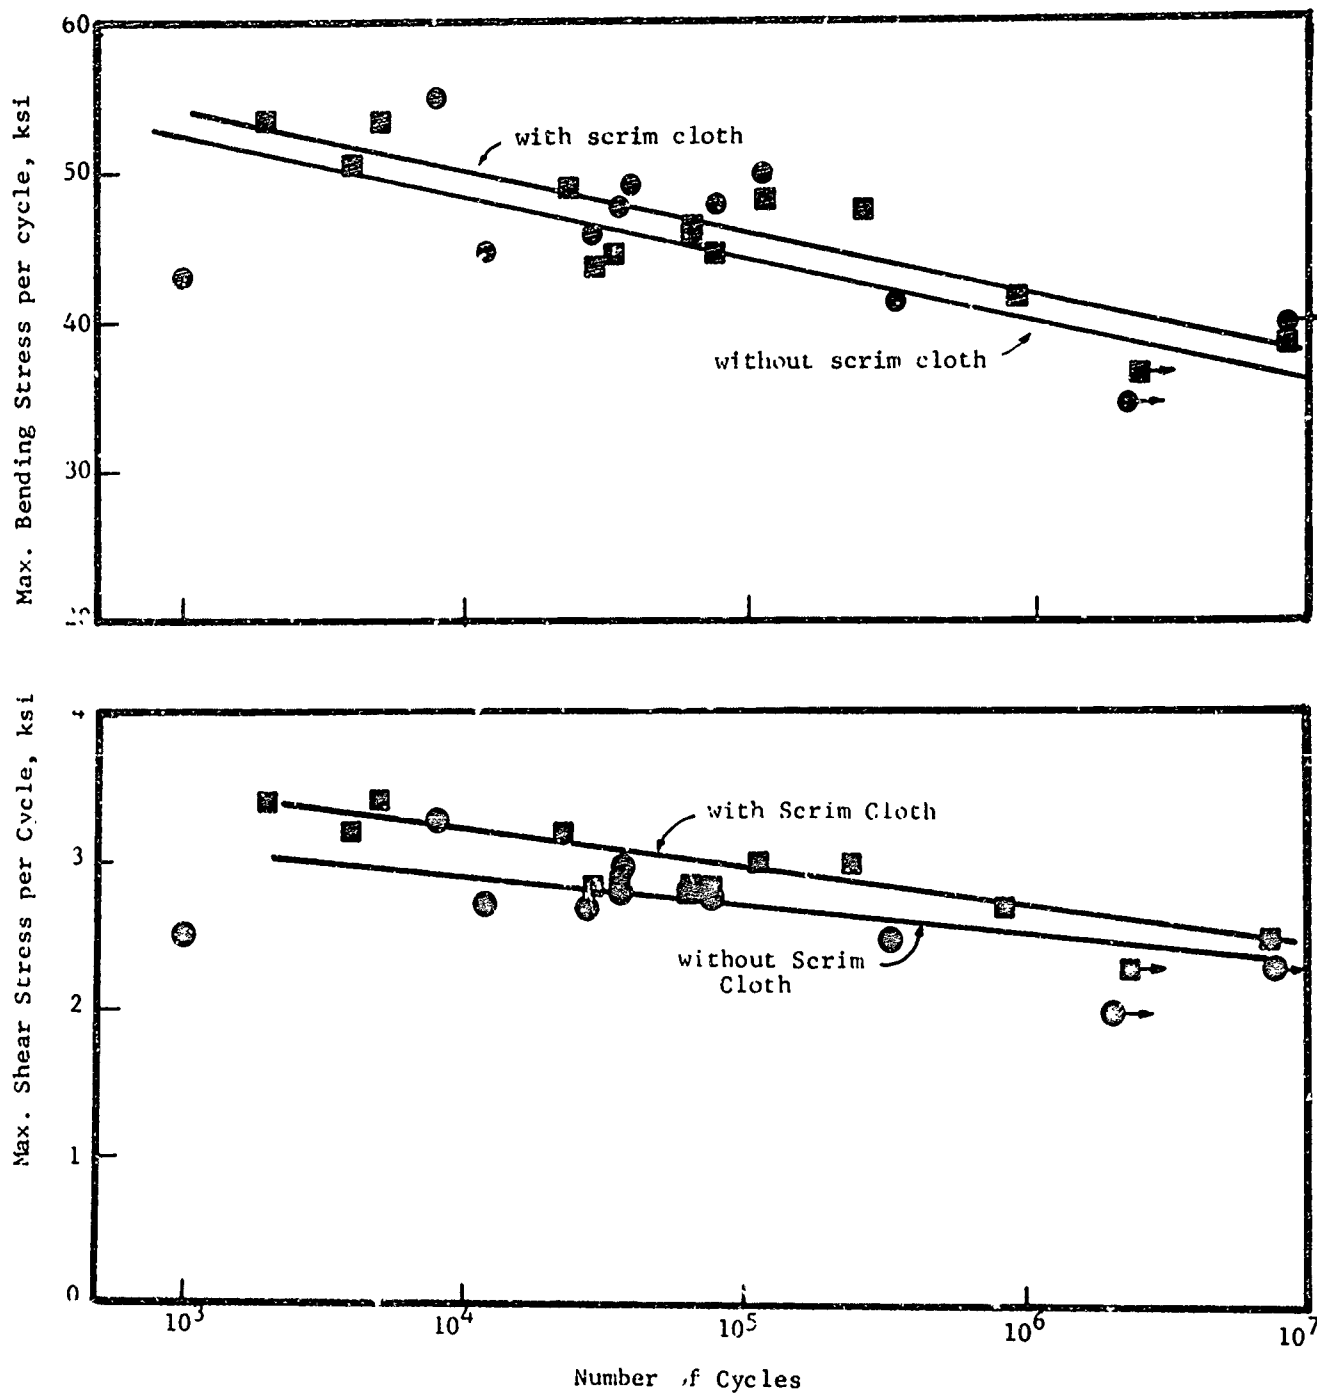
FIG. 4 SUMMARY OF FATIGUE RESULTS FOR MODMOR II/NARMCO 5206 PREPREG 16 PLY (45°/135°) COMPOSITE CANTILEVER BEAM TESTS AT $R = 0.1$, ROOM TEMPERATURE DRY CONDITIONS.

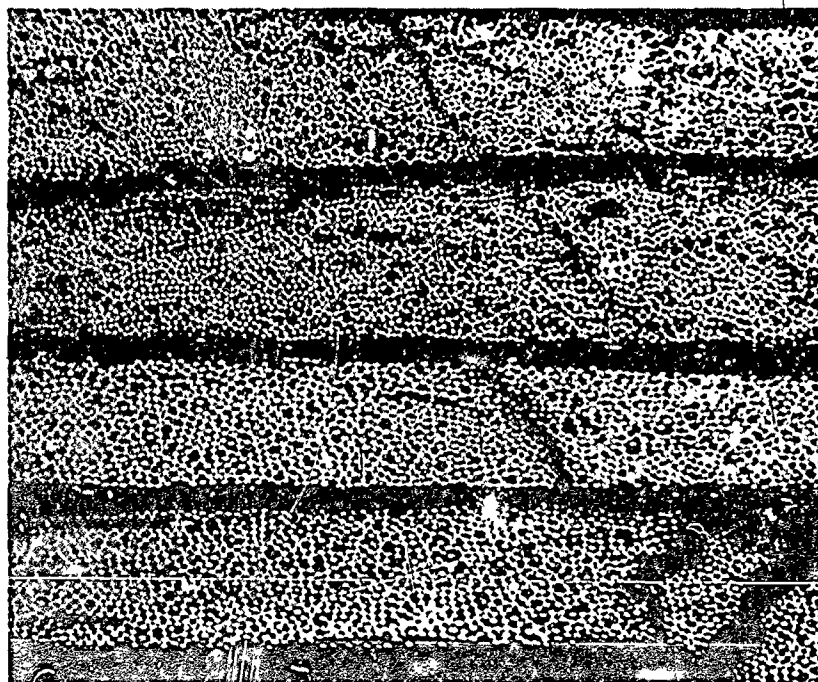
FIG. 7 CROSS SECTIONAL PHOTOMICROGRAPH OF MODMOR II/
NARMCO 5206 16 PLY COMPOSITE CANTILEVER BEAM
SPECIMEN SUBJECTED TO FATIGUE ($R = 0.1$) STRESS
CYCLES AT ROOM TEMPERATURE.

SPECIMEN NO. 7C-12 MAGNIFICATION 100X FIBER
ORIENTATION $0^\circ / +45^\circ / 90^\circ$ (WITH SCRIM CLOTH)
MAXIMUM LOAD 210 LBS. (60.4% OF ULTIMATE)
NO. OF STRESS CYCLES 100,000

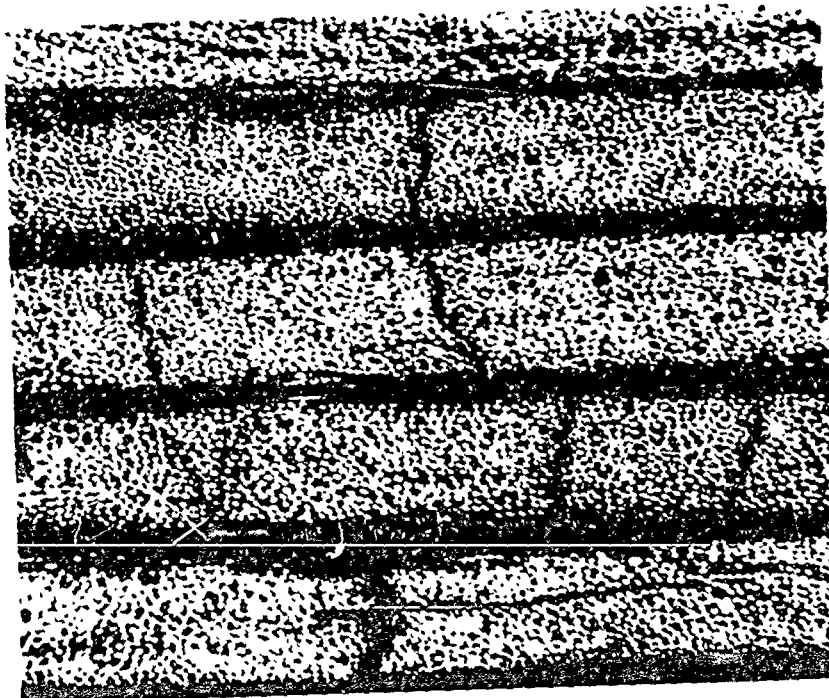
FIG. 9 CROSS SECTIONAL PHOTOMICROGRAPH OF MODMOR II/
NARMCO 5206 16 PLY COMPOSITE CANTILEVER BEAM
SPECIMEN SUBJECTED TO FATIGUE ($R = 0.1$) STRESS
CYCLES AT ROOM TEMPERATURE.

SPECIMEN NO. 4D-13, MAGNIFICATION 100X, FIBER
ORIENTATION $45^\circ / 135^\circ$ (WITH SCRIM CLOTH)
MAXIMUM LOAD 174 LBS. (59.6% OF ULTIMATE)
NO. OF STRESS CYCLES 500,000

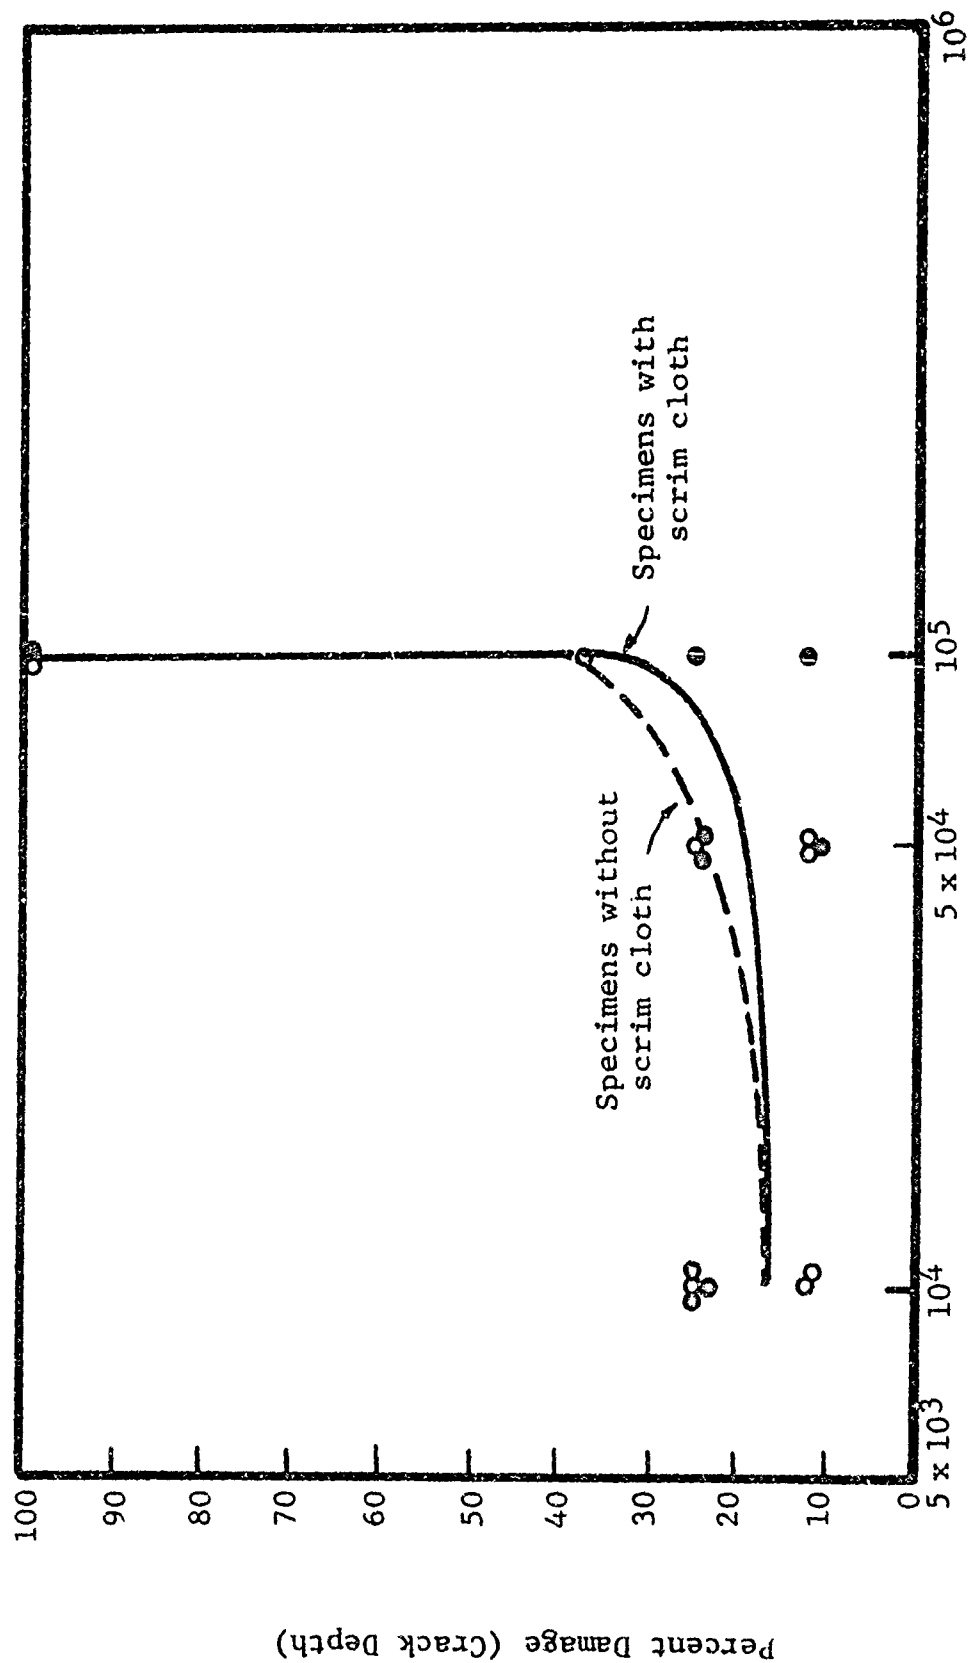
FIG. 10 PERCENT DAMAGE (CRACK DEPTH) TO MODMOR II/NARMC 5206 16 PLY -
 0°, + 45°, 90° COMPOSITE CANTILEVER BEAM SPECIMENS INSPECTED
 MICROSCOPICALLY AFTER STRESS CYCLING (ROOM TEMPERATURE, DRY)

There is scatter apparent in the data because of discontinuous way in which the cracks penetrate plies. Laminate cracking occurs in stages, from ply to ply, following borders of tows and lamina interfaces rather than continuously as in the case of homogeneous material and thus intermediate stages of damage are not apparent.

It should be noted also that the crack depth in the cross section of the beam at the support does not give an indication of the total area in which cracking has taken place. Thus the total energy required to produce all the crack surfaces has not been accounted for in simple crack depth measurements.

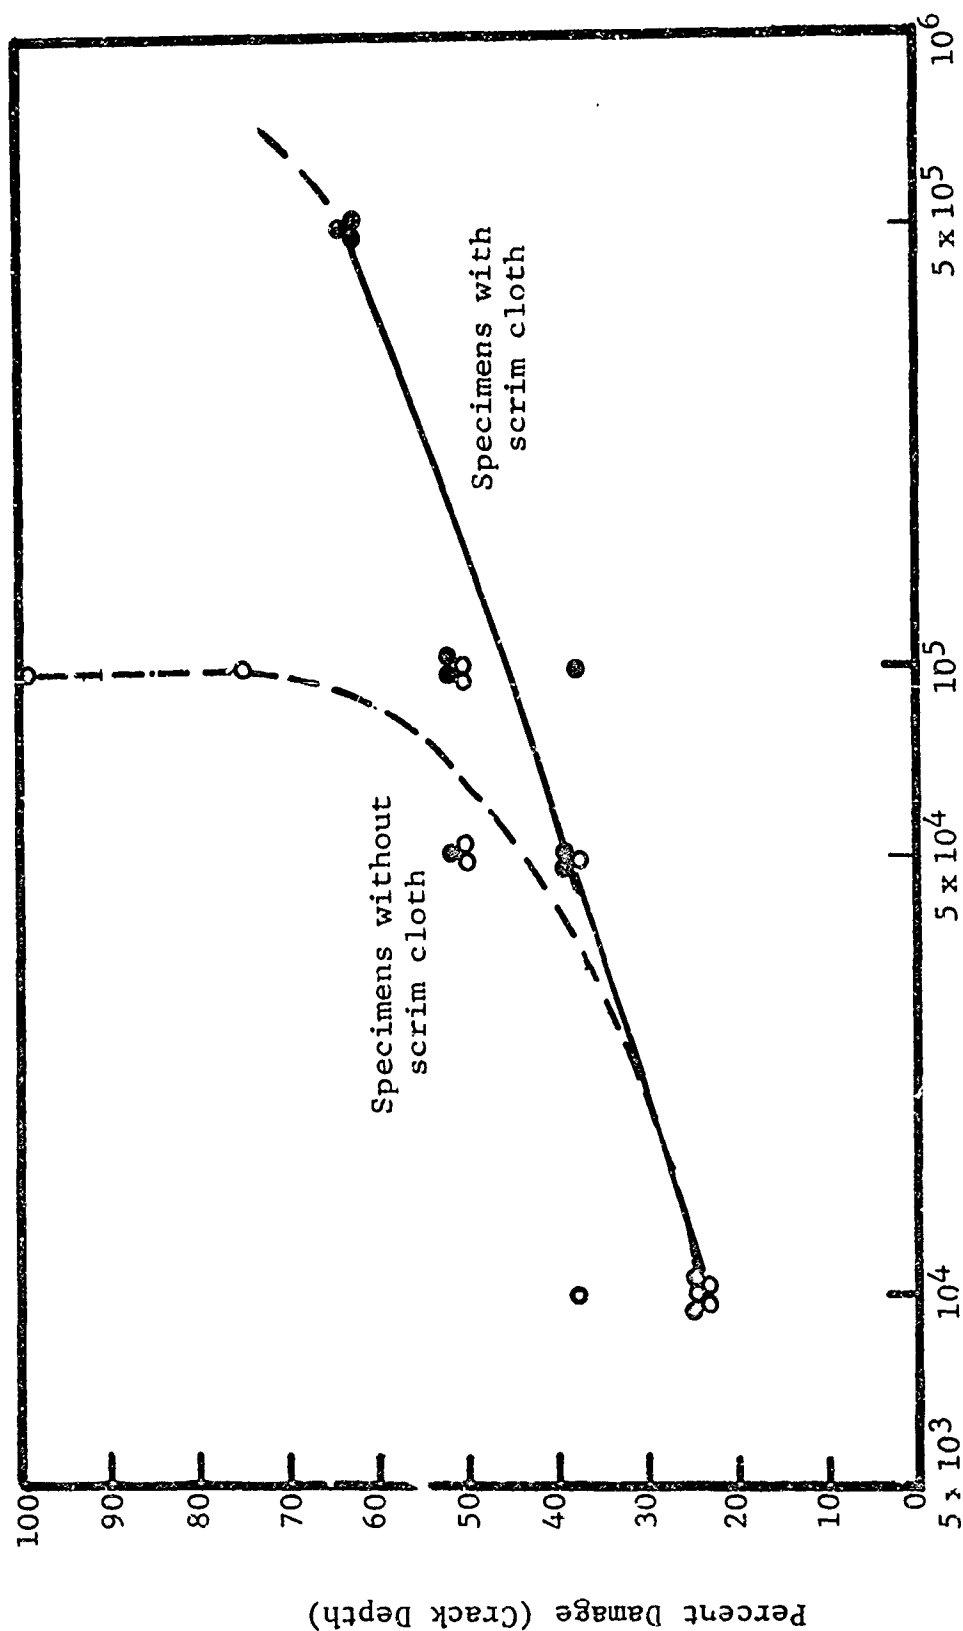
FIG. 11
 Number of Stress Cycles applied before Sectioning
 PERCENT DAMAGE (CRACK DEPTH) TO MODMOR II/NARMC0 5206 16 PLY -
 45°, 135° COMPOSITE CANTILEVER BEAM SPECIMENS INSPECTED
 MICROSCOPICALLY AFTER STRESS CYCLING (ROOM TEMPERATURE, DRY)

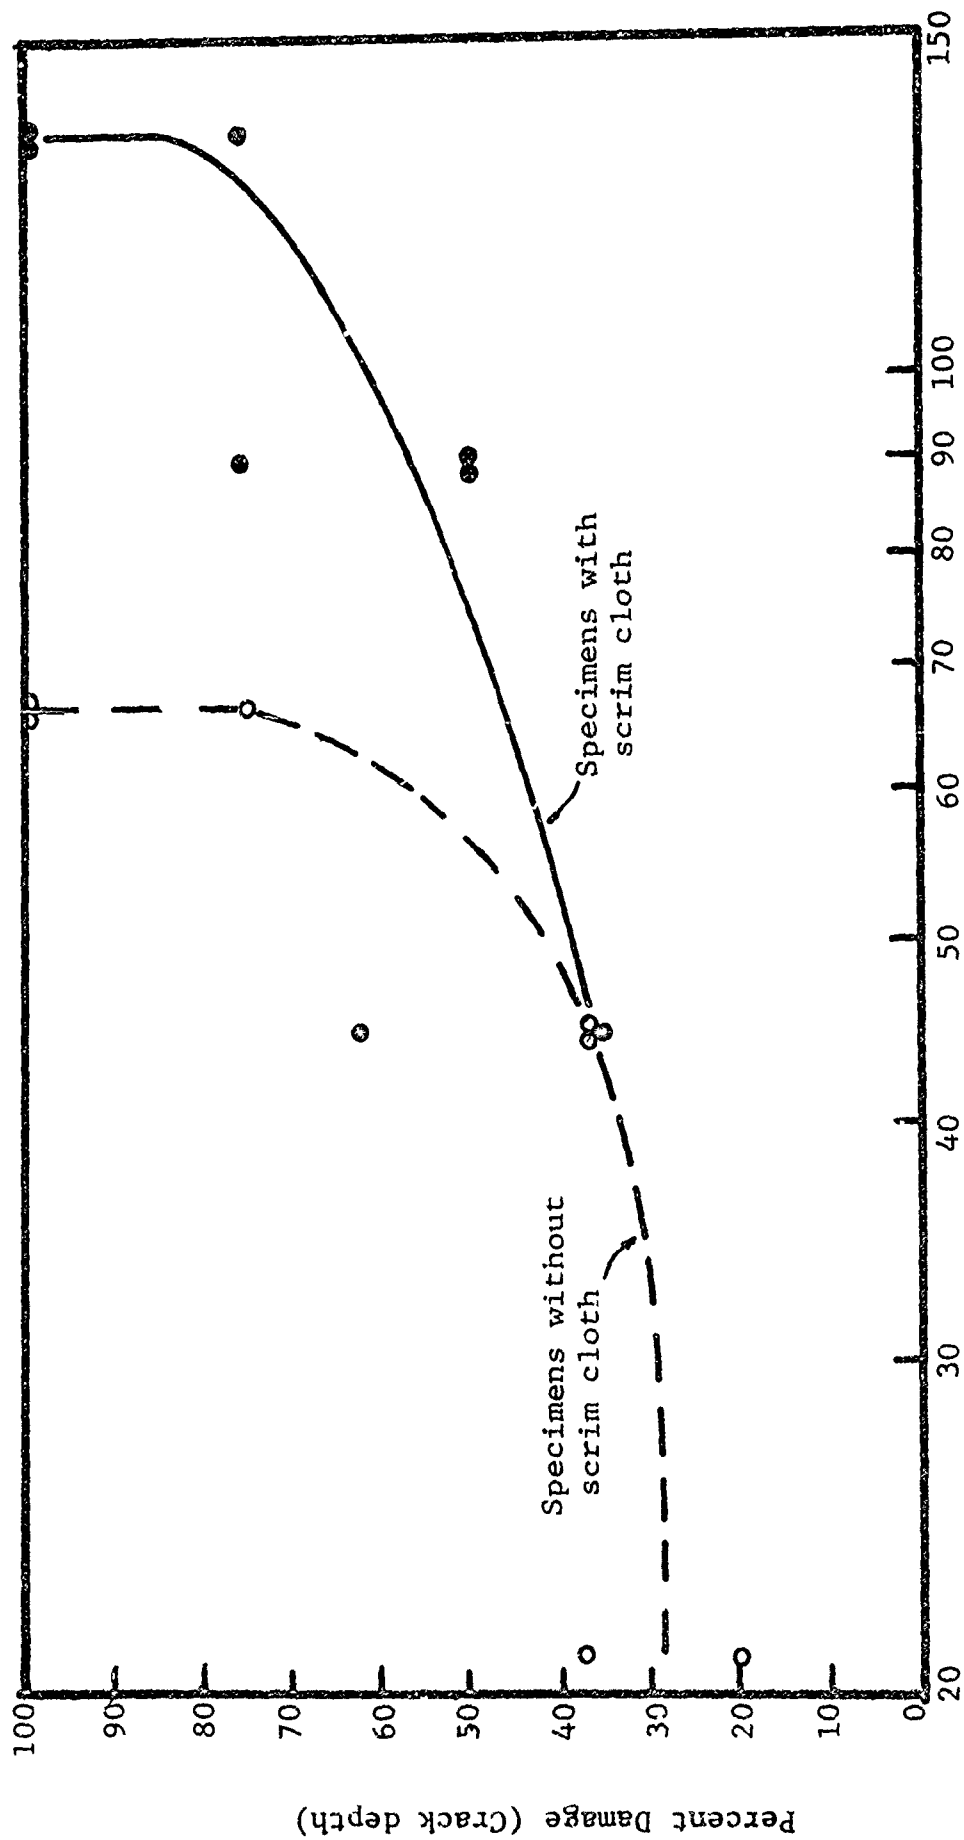
FIG. 12 PERCENT DAMAGE (CRACK DEPTH) TO MODMOR II/NARMC0 5206 16 PLY - 45°, 135° COMPOSITE CANTILEVER BEAM SPECIMENS INSPECTED MICROSCOPICALLY AFTER SEQUENTIAL LOAD FATIGUE ($R = 0.1$) STRESS CYCLING (ROOM TEMPERATURE, DRY.)

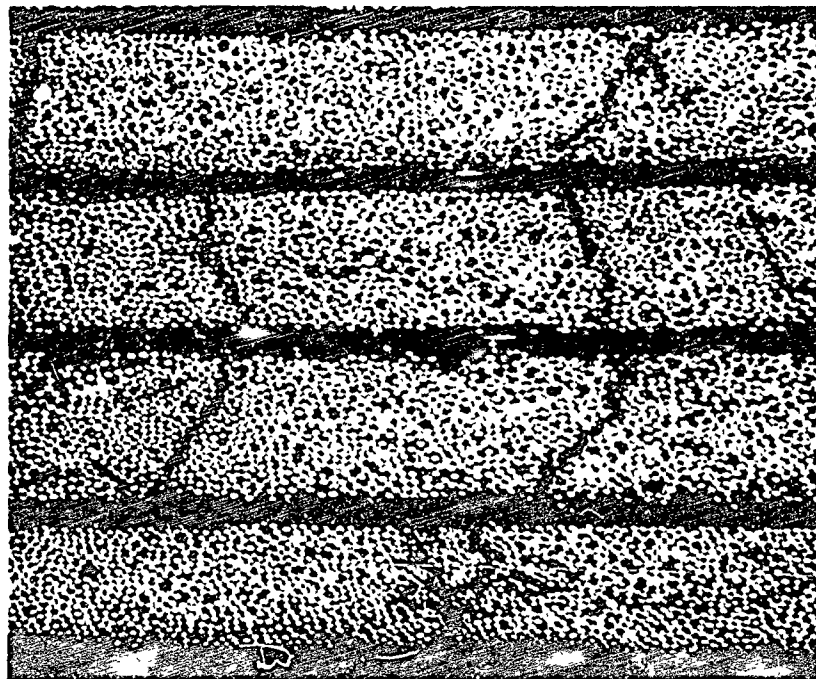
FIG. 13 CROSS SECTIONAL PHOTOMICROGRAPH OF MODMOR II/
NARMCO 5206 16 PLY COMPOSITE CANTILEVER BEAM
SPECIMEN SUBJECTED TO FATIGUE ($R = 0.1$) LOAD
SEQUENCES AT ROOM TEMPERATURE.

SPECIMEN NO. 4D-41, MAGNIFICATION 100X, FIBER
ORIENTATION 45° , 135° (WITH SCRIM CLOTH)
NO. OF BLOCKS 135.

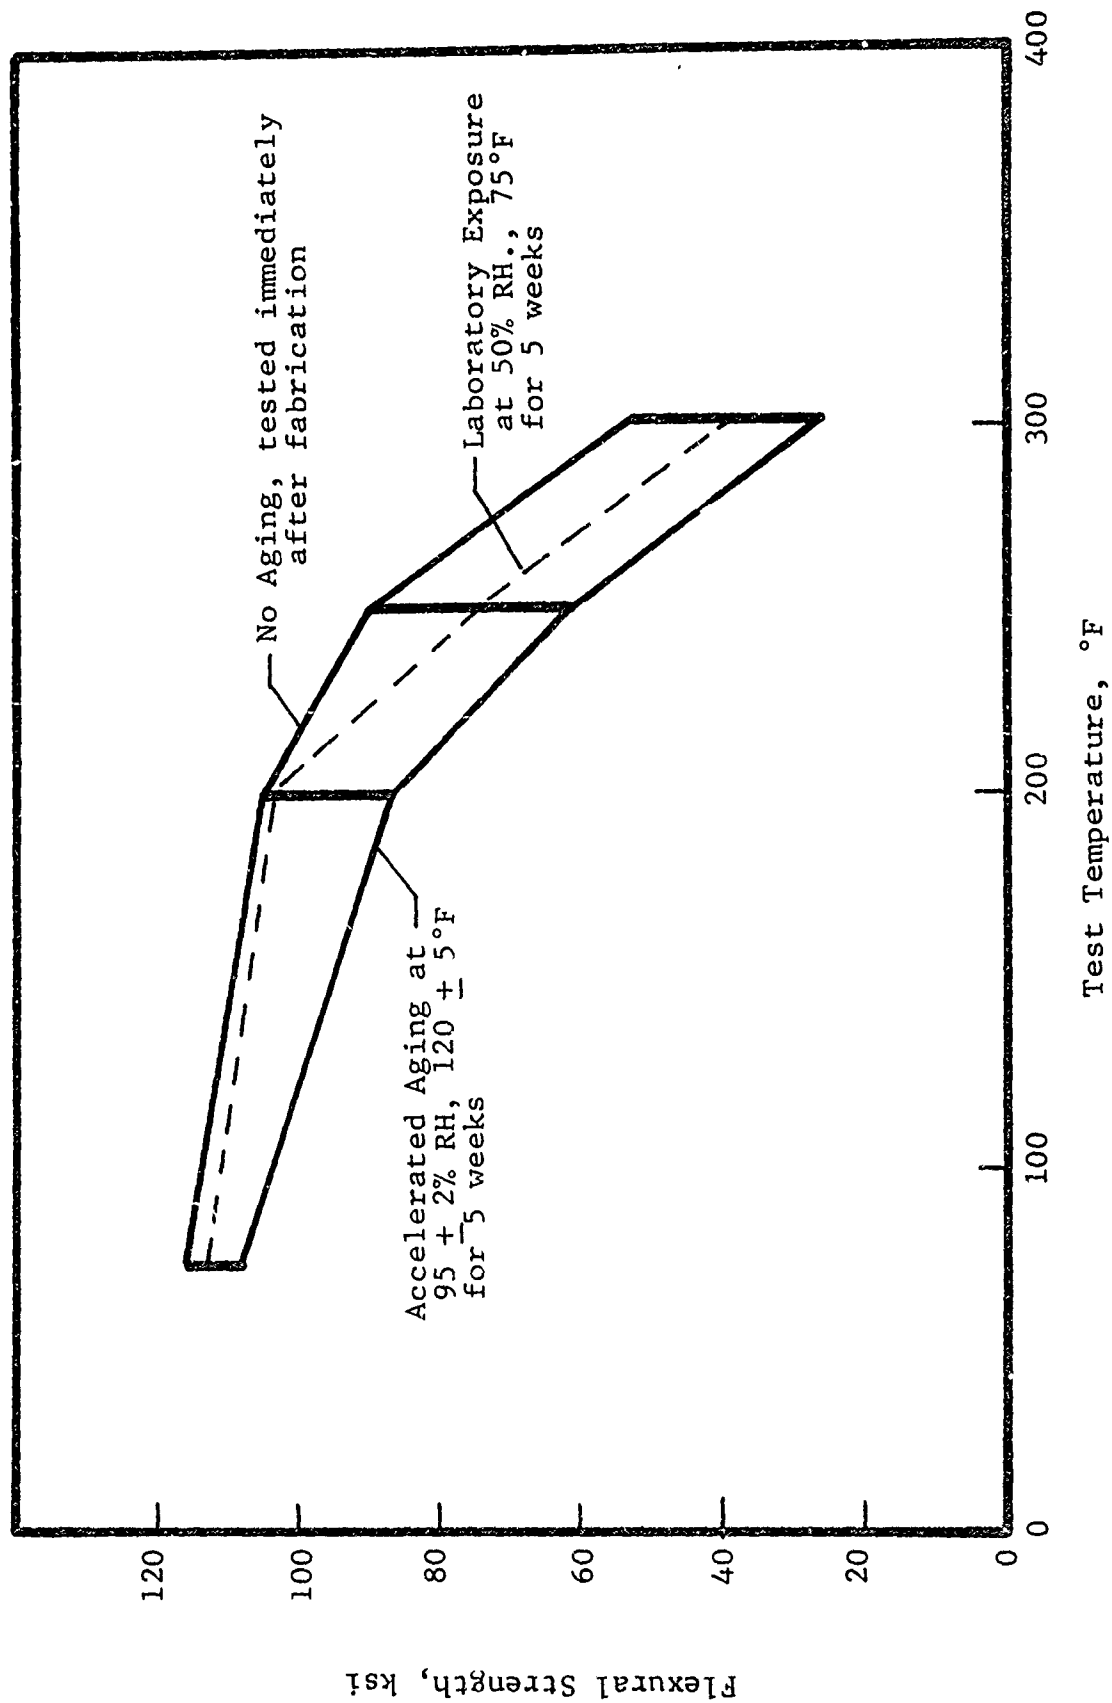
FIG. 14 FLEXURAL STRENGTHS OF MODMOR II/NARMCO 5206 COMPOSITES,
16 PLY - 0°, 90° PLY ORIENTATION

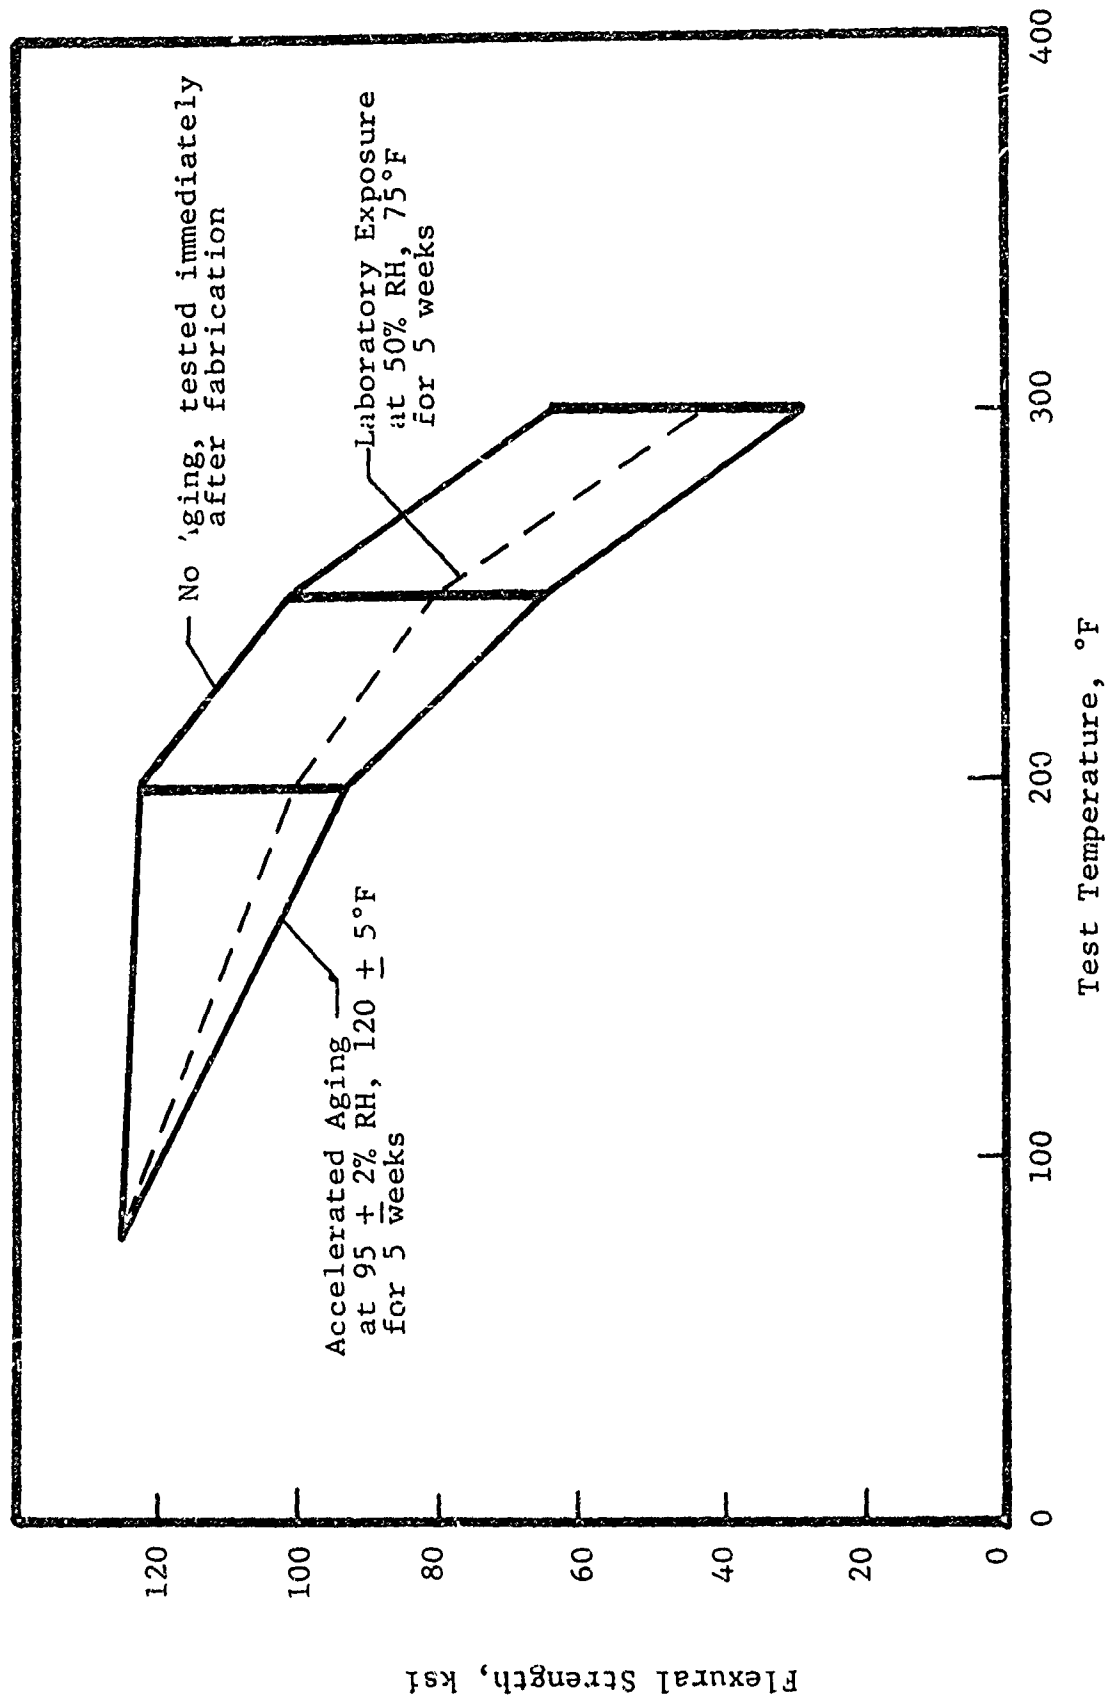
FIG. 15 FLEXURAL STRENGTHS OF MODMOR II/NARMCO 5206 COMPOSITES,
16 PLY - 0°, 90° PLY ORIENTATION (WITH SCRIM CLOTH)

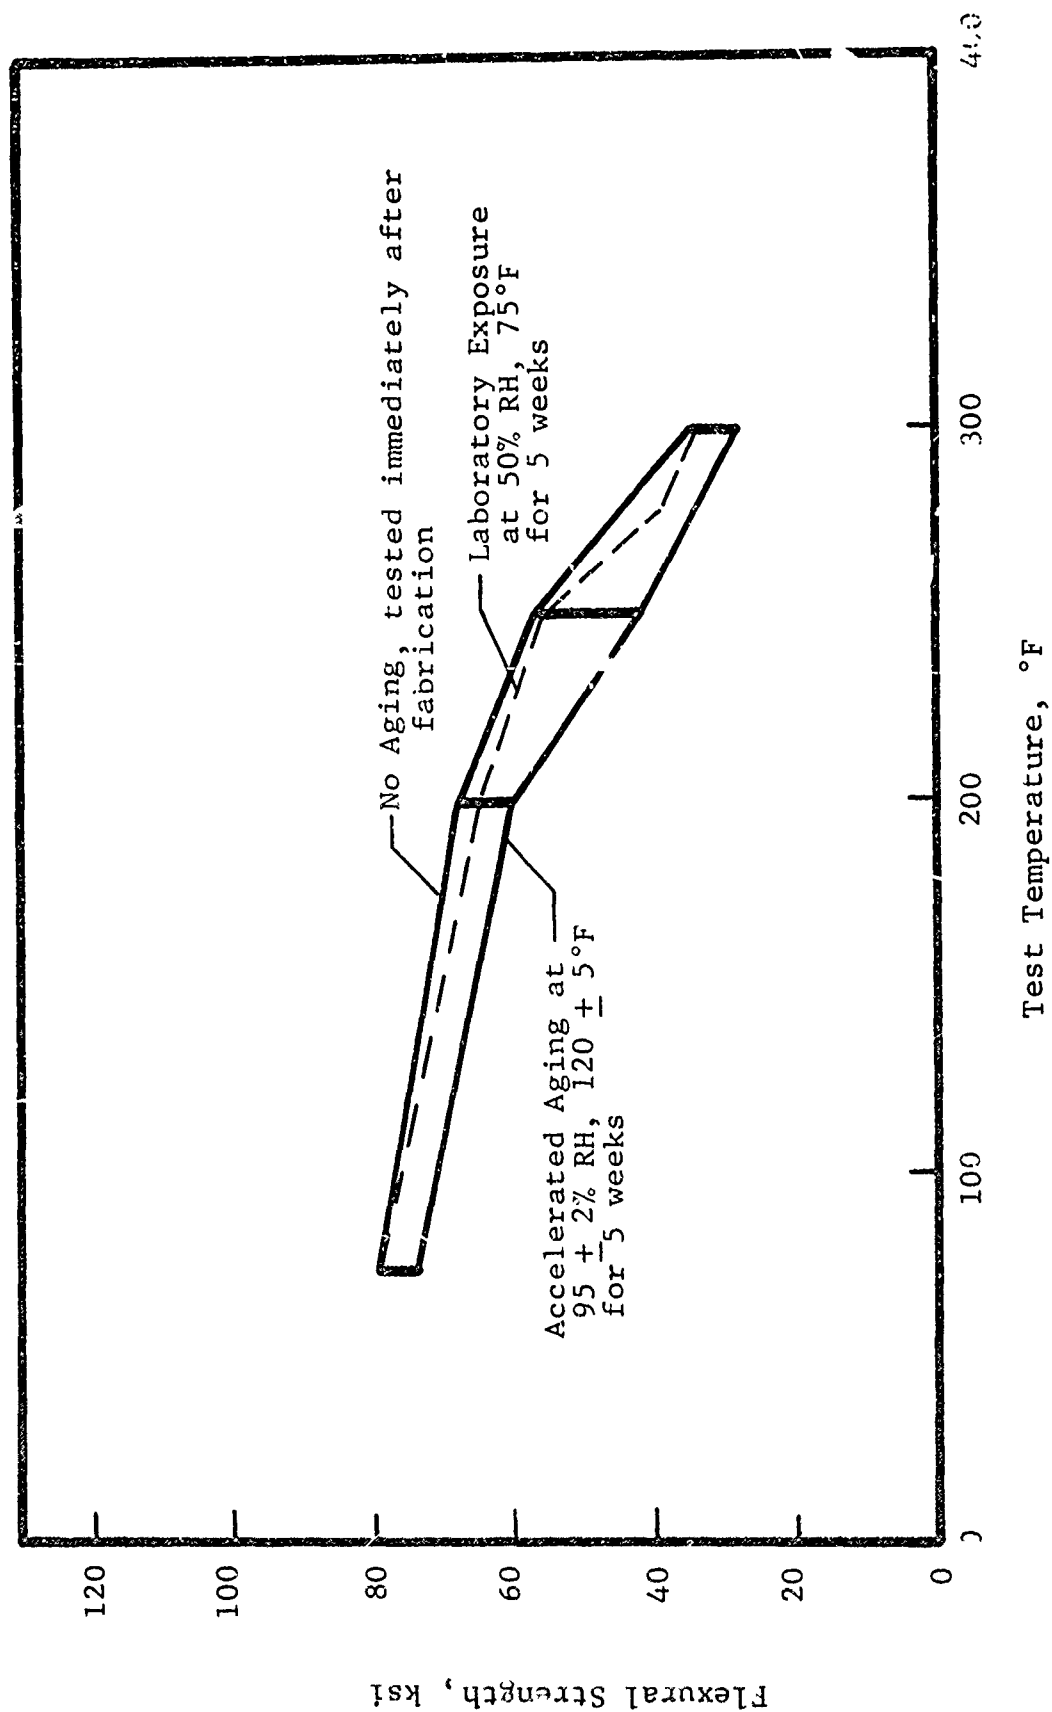
FIG. 16 FLEXURAL STRENGTHS OF MODMOR II/NARMCO 5206 COMPOSITES,
16 PLY - 0°, 90° + 45° PLY ORIENTATION

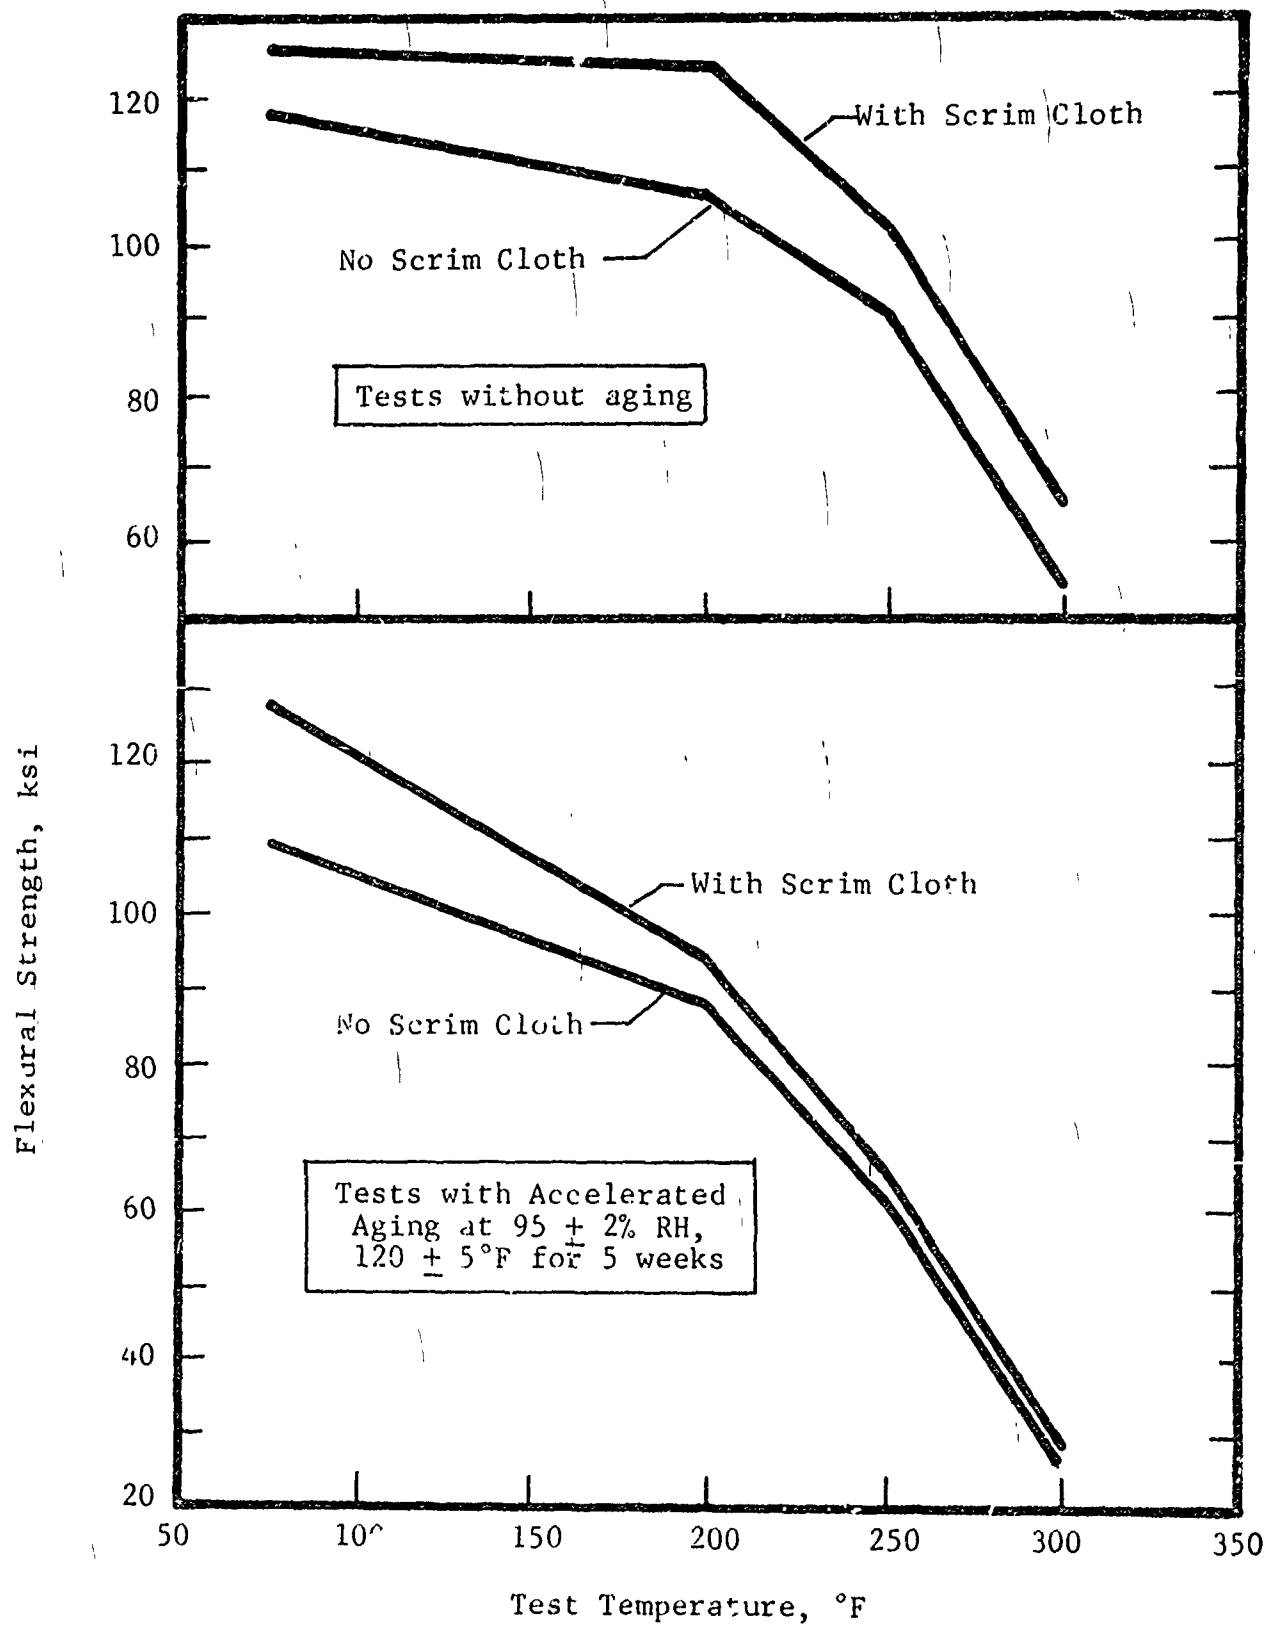
FIG. 17 FLEXURAL STRENGTHS OF MODMOR II/NARMCO 5206 COMPOSITES, 16 PLY - 0°, 90°, PLY ORIENTATION

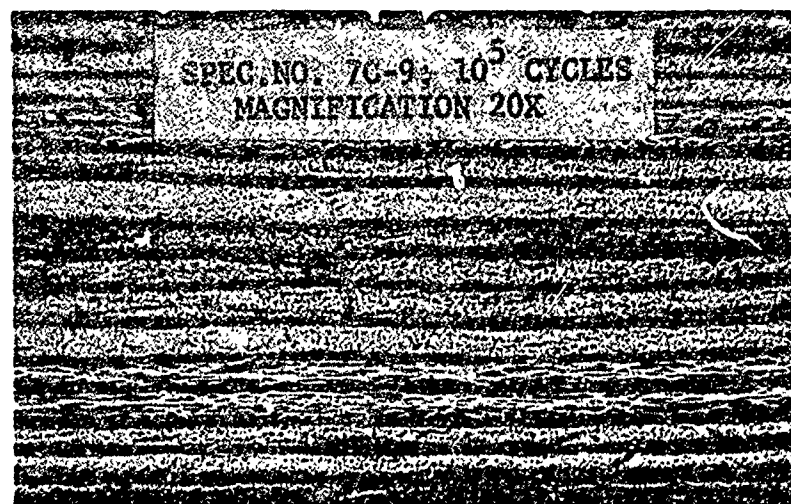
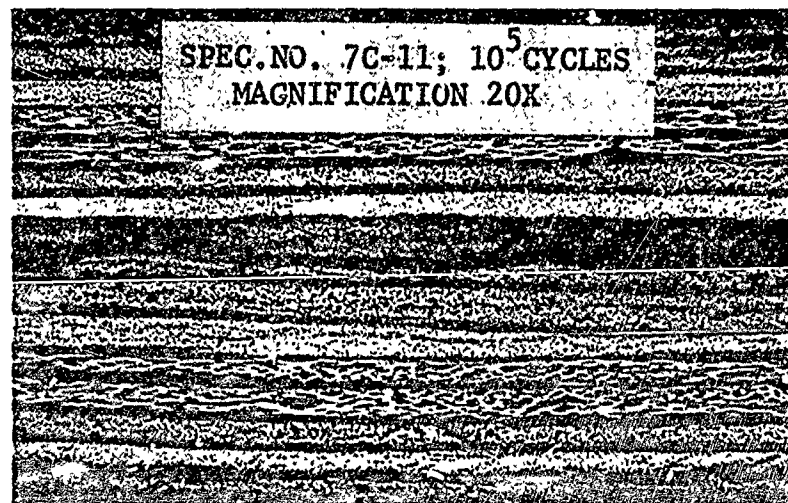
FIG. A-6 CROSS SECTIONAL PHOTOMICROGRAPHS OF MODMOR II/NARMCO 5206 PREPREG 16 PLY - 0°/ + 45°/90° (WITH SCRIM CLOTH) COMPOSITE CANTILEVER BEAM SPECIMENS SUBJECTED TO VARIOUS FATIGUE STRESS CYCLES AT R = 0.1 (MAX. LOAD/CYCLE = 210 LBS), ROOM TEMPERATURE, DRY.

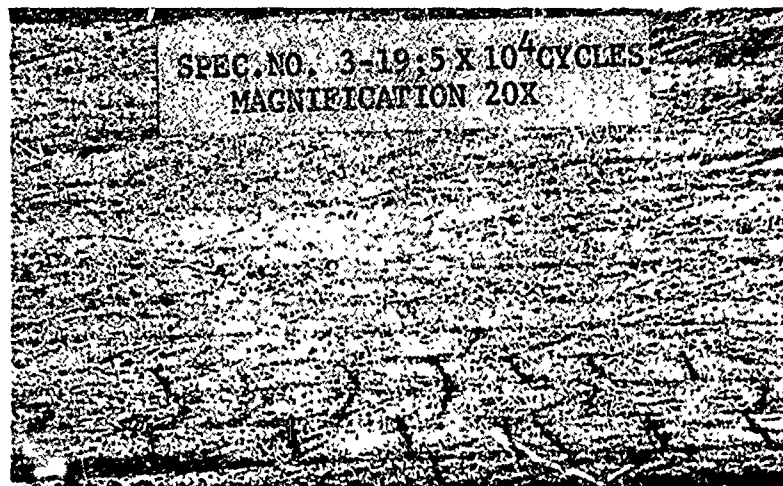
FIG. A-8 CROSS SECTIONAL PHOTOMICROGRAPH OF MODMOR II/NARMCO 5206 PREPREG 16 PLY - 45°/135° COMPOSITE CANTILEVER BEAM SPECIMENS SUBJECTED TO VARIOUS FATIGUE STRESS CYCLES AT R = 0.1 (MAX. LOAD/CYCLE = 168 LBS), ROOM TEMPERATURE, DRY.

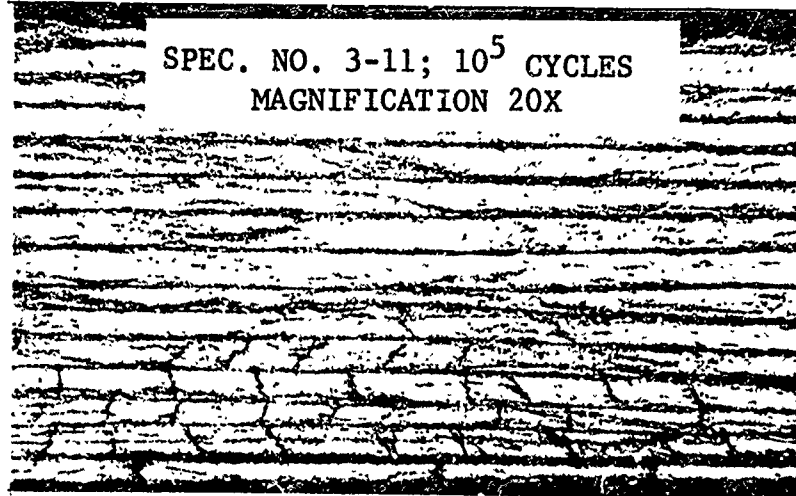
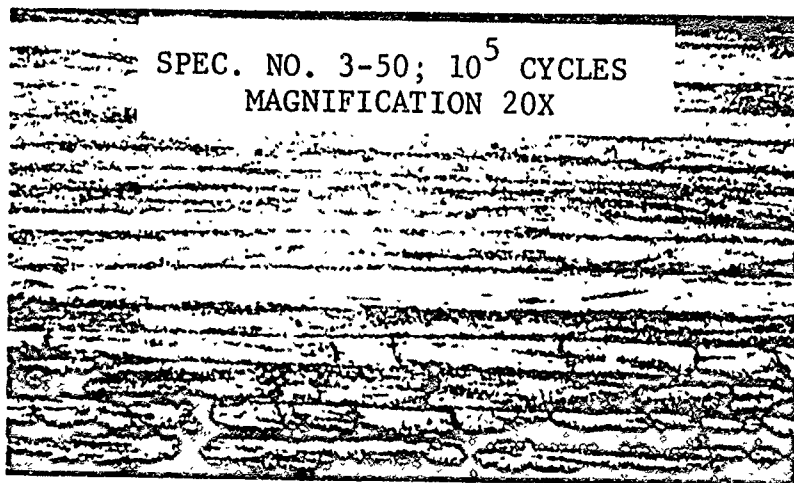
FIG. A-9 CROSS SECTIONAL PHOTOMICROGRAPHS OF MODMOR II/NARMCO 5206 PREPREG 16 PLY - $45^\circ/135^\circ$ COMPOSITE CANTILEVER BEAM SPECIMENS SUBJECTED TO VARIOUS FATIGUE STRESS CYCLES AT $R = 0.1$ (MAX. LOAD/CYCLE = 168 LBS), ROOM TEMPERATURE, DRY.

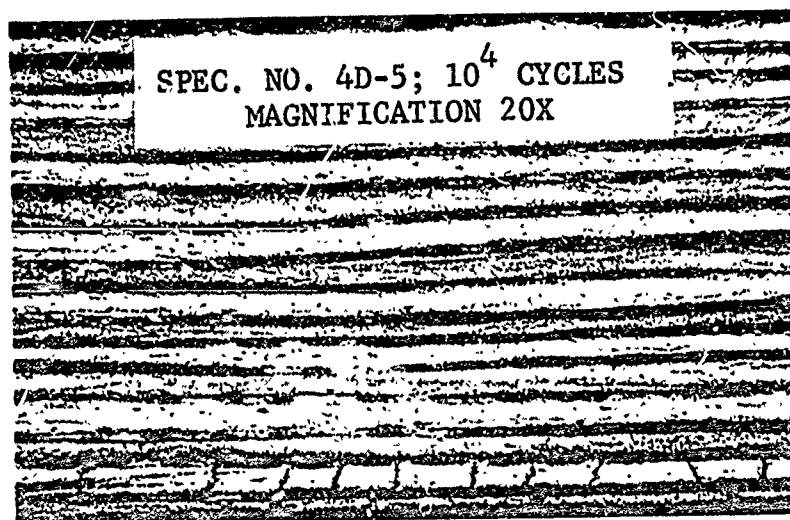
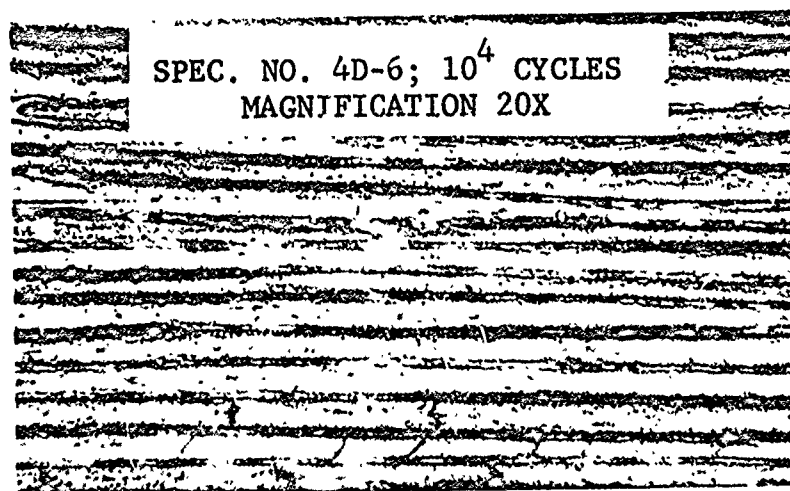
FIG. A-10 CROSS SECTIONAL PHOTOMICROGRAPHS OF MODMOR II/NARMCO 5206 PREPREG 16 PLY - $45^\circ/135^\circ$ (WITH SCRIM CLOTH) COMPOSITE CANTILEVER BEAM SPECIMENS SUBJECTED TO VARIOUS FATIGUE STRESS CYCLES AT $R = 0.1$ (MAX. LOAD/CYCLE = 174 LBS), ROOM TEMPERATURE, DRY.

<u>Specimen No.</u>	<u>No. of Cycles *</u>	<u>Figure No.</u>
4D-1	10,000	A-10
4D-5	10,000	A-10
4D-6	10,000	A-10
4D-24	50,000	A-11
4D-33	50,000	A-11
4D-65	50,000	A-11
4D-8	100,000	A-12
4D-34	100,000	A-12
4D-38	100,000	A-12
4D-13	500,000	A-13
4D-55	500,000	A-13
4D-60	500,000	A-13

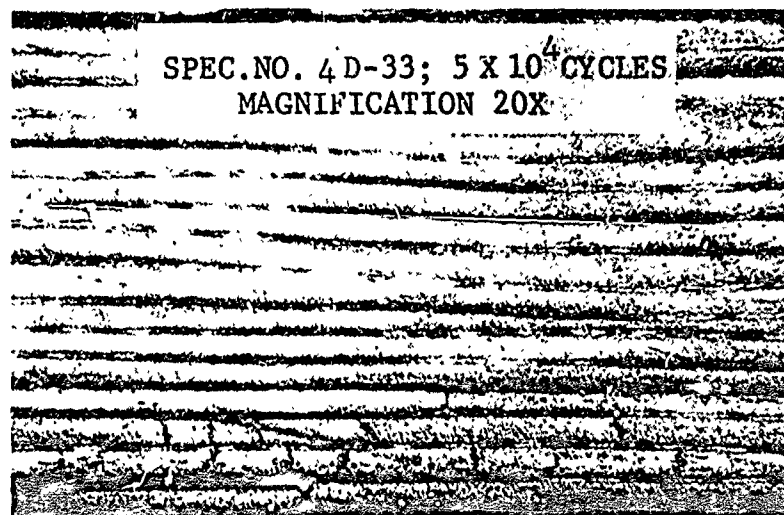
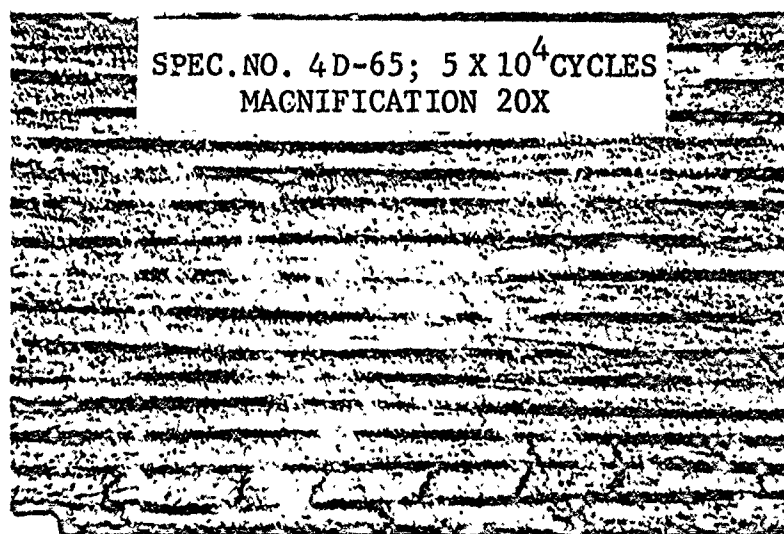
FIG. A-11 CROSS SECTIONAL PHOTOMICROGRAPHS OF MODMOR II/NARMCO 5206 PREPREG 16 PLY - $45^\circ/135^\circ$ (WITH SCRIM CLOTH) COMPOSITE CANTILEVER BEAM SPECIMENS SUBJECTED TO VARIOUS FATIGUE STRESS CYCLES AT $R = 0.1$ (MAX. LOAD/CYCLE = 174 LBS), ROOM TEMPERATURE, DRY.
